APPENDIX E
THREATENED AND ENDANGERED SPECIES
REPORTS

Survey of Stream Fish Habitat at Five Potential Bridge Crossing Sites for the New U.S. Route 220 Southern Connector (Martinsville, VA)

Project Report
Project: UPC 110916

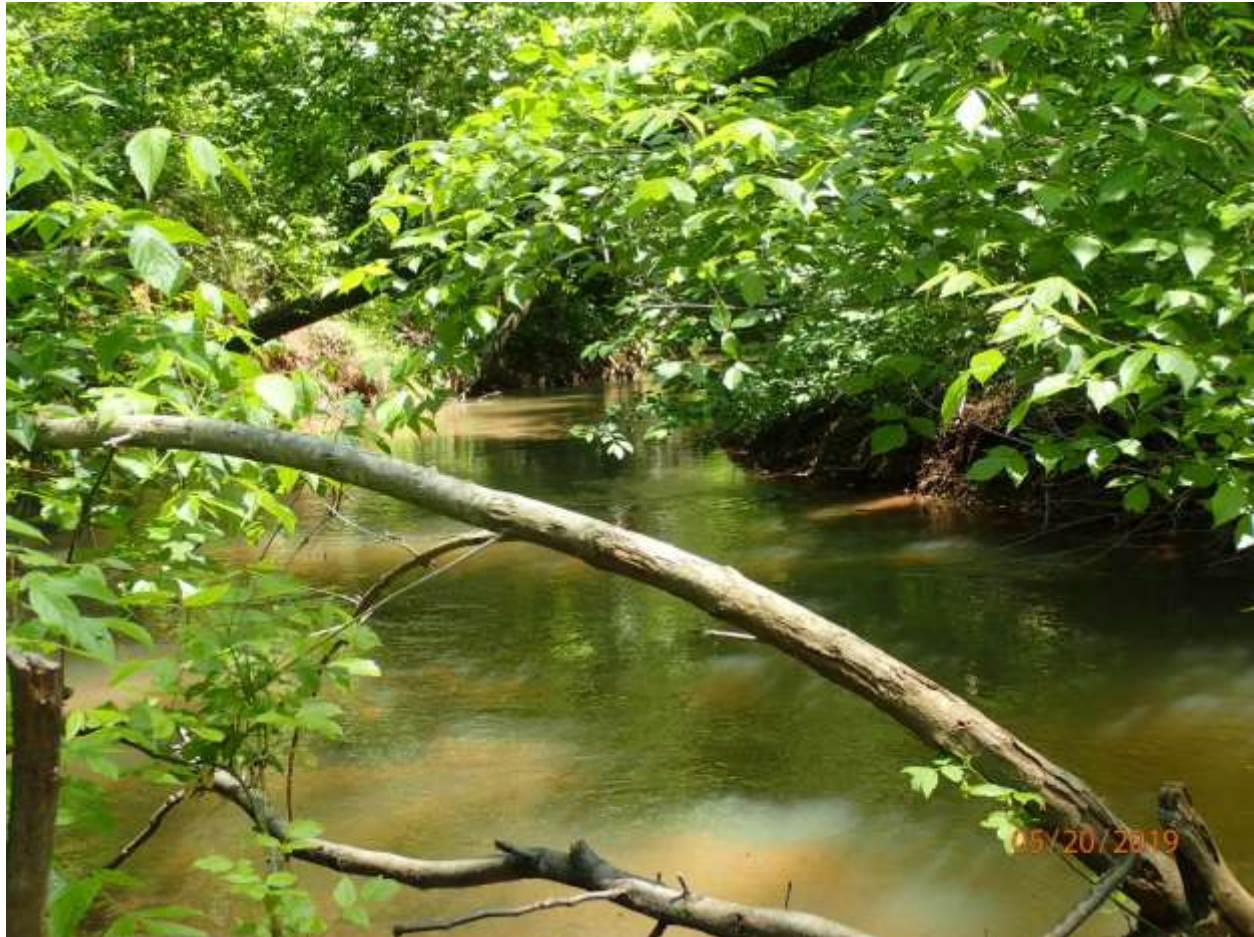
Figure 5. Mussel habitat assessment site at the Route 220 Bypass Alternative Route D crossing of Marrowbone Creek, Henry County, Virginia, surveyed on May 21, 2019.

The site was ≈ 270 m south-southeast of our parking site at the creek-side dead-end of Farmingdale Drive. From the parking site, we hiked across a small creek and then through overgrown fields to the site (Table 1, Fig. 1). The riparian zone was shaded due to complete coverage by lush undergrowth and trees. The channel was deeply incised, with the left and right descending bank heights of 2.5 and 3.0 m, respectively (VDOT Survey Collection Record – Marrowbone Creek – ALT D, Fig. 5), and with no wood debris. The bottom substratum was unsuitable for mussels, consisting of loose sand, silt, and small areas of fine gravel, with water

depth of ≈ 0.3 m. No mussels were observed during 0.5 h of search time (VDOT Survey Collection Record – Marrowbone Creek – ALT D, Table 1). Live *C. fluminea* were common in the fine gravel. No crayfish or fish were observed.

Comments: Viewscopes only. No muskrat middens. Corbicula – uncommon. Riparian – thick, shaded canopy; deeply incised channel – left descending bank 2.5 m, right descending bank 3 m; substrate very unstable – fine sand/silt with very few areas of fine gravel. Water depth mean about 0.3 m. No crayfish or adult fish observed.

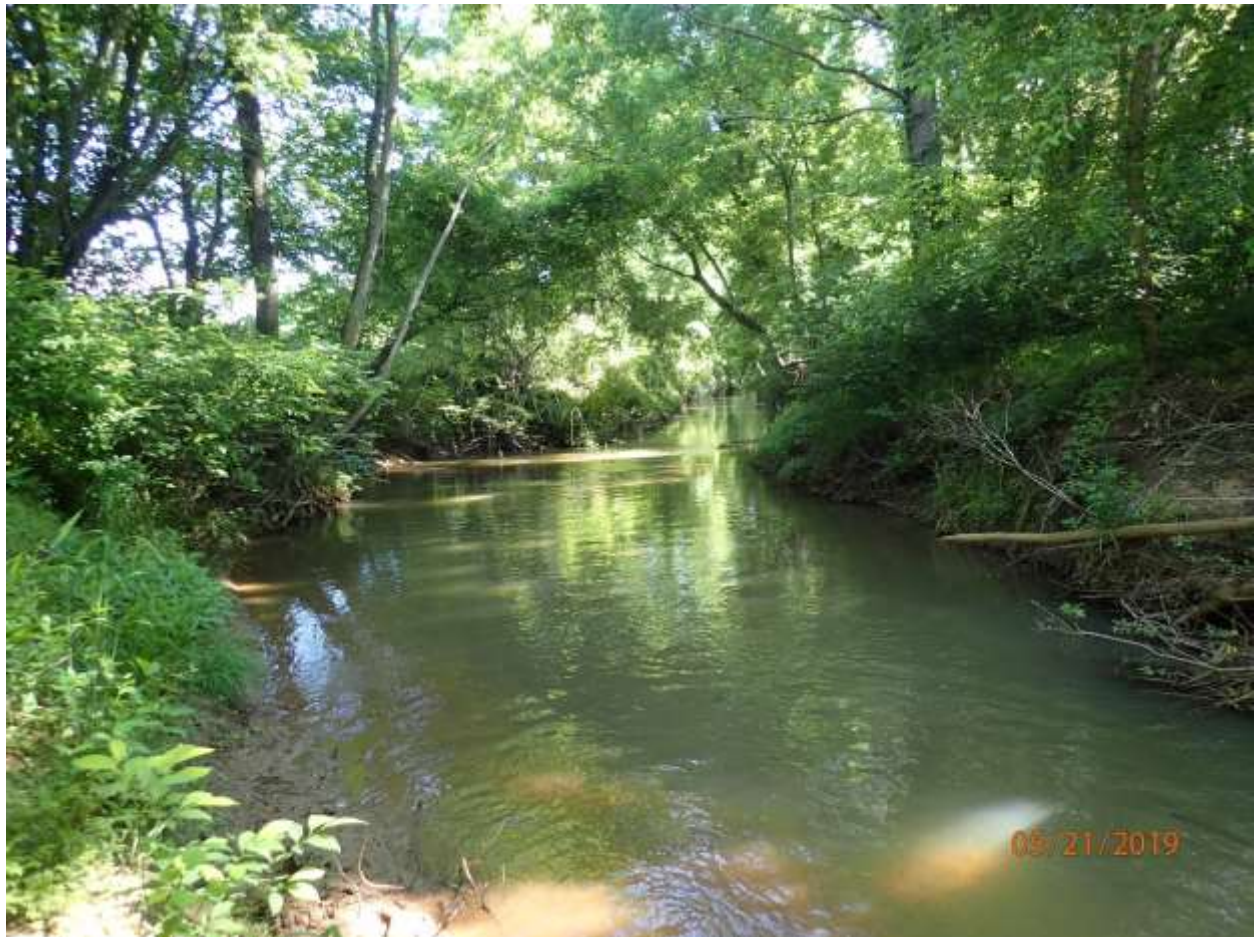
Figure 6. Mussel habitat assessment site at the Route 220 Bypass Alternative Route E crossing of Marrowbone Creek, Henry County, Virginia, surveyed on May 21, 2019.

The site was ≈ 115 m north of our parking site at a Salvation Army drop-off shed on the west side of Highway 220. From the parking site, we walked through a small mowed field to the site (Table 1, Fig. 1). The riparian zone was shaded by lush undergrowth and trees. The channel was deeply incised, with the left and right descending bank heights of 2.5 and 1.5 m, respectively (VDOT Survey Collection Record – Marrowbone Creek – ALT E, Fig. 6). The left descending bank was lush and forested, and the right bank was mown. The bottom substratum was unsuitable for mussels, and consisted of loose sand, silt, and patches of fine gravel. Water depth was ≈ 0.3 m. No mussels were observed during the 0.5 h of search time (VDOT Survey Collection Record – Marrowbone Creek – ALT E, Table 1). Live *C. fluminea* were present in the fine gravel patches. No crayfish or fish were observed.

Comments: Viewscopes only. No muskrat middens. Riparian – thick, shaded canopy on left descending bank, mowed field on right descending bank; deeply incised channel – left descending bank 2.5 m, right descending bank 1.5 m; substrate very unstable – fine sand/silt with very few areas of fine gravel. Water depth mean about 0.3 m. Sparse submerged woody debris and no fallen logs observed. No crayfish or fish observed.
